## Elite Optima assessment of kneading motor bracket or frame damage

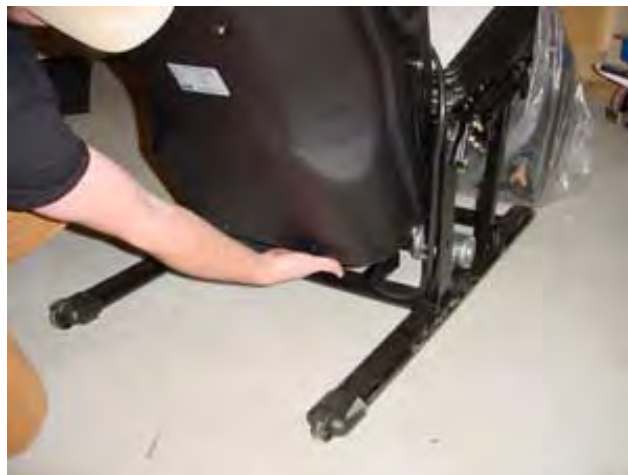
**Step 1:** Lay the back of the chair down over the seat of the chair.

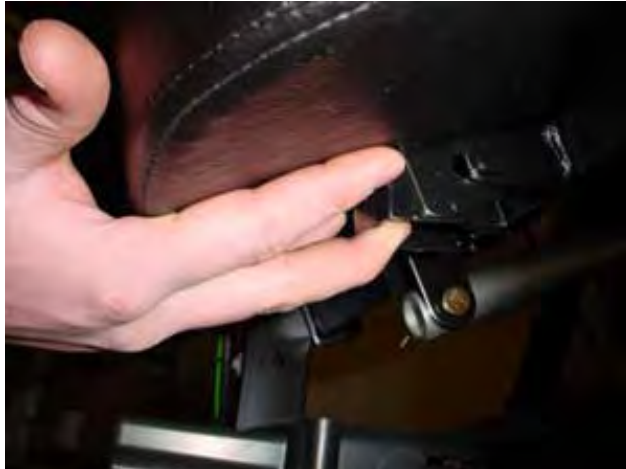
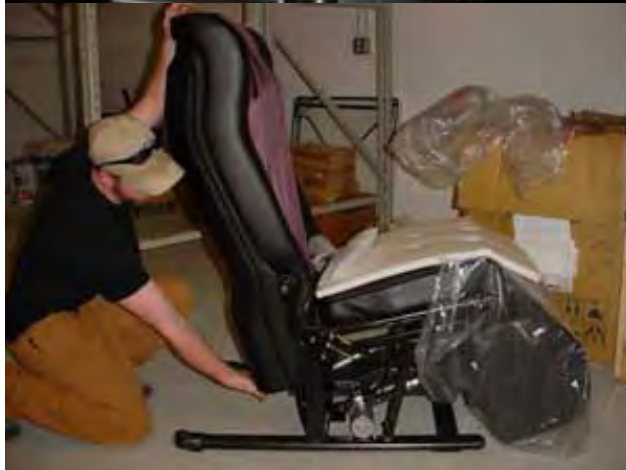
Reach under the back of the chair with your right hand.....about 6” in from the left side and about 4” in from the back cover. Locate the latch mechanism with a finger and pull latch out to release.

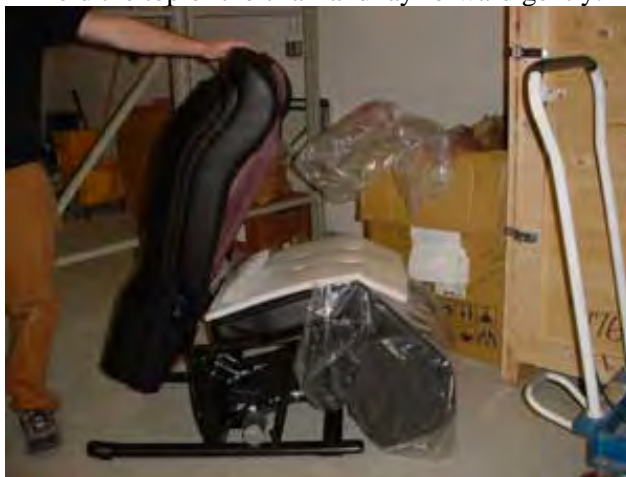
CAUTION, when the latch is released, the back will be free weight and will pivot.  
Hold the top of the chair and lay forward gently.

Hold onto the seat back until it is firmly lying on the seat.  
*DO NOT ALLOW chair back to 'drop' unsupported onto the seat.*

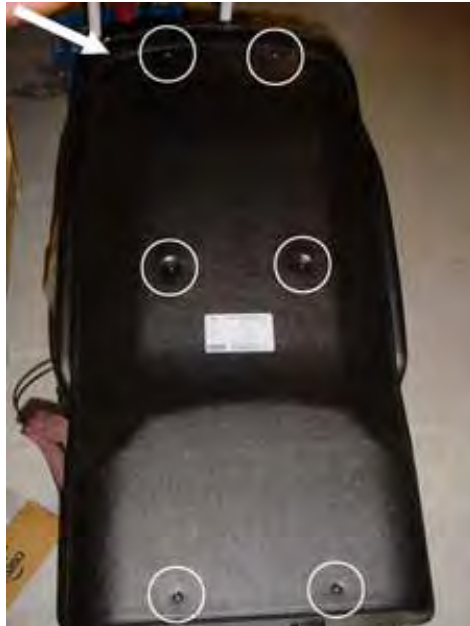
**Step 2:** Once the back of the chair is folded down and you are ready to begin, locate the six screws holding the back cover on.

Using your # 2 Phillips screw driver remove the six screws.  
Disconnect the two air hoses in the upper left corner of cover as shown with arrow above. Lift the back cover up and off and set aside.

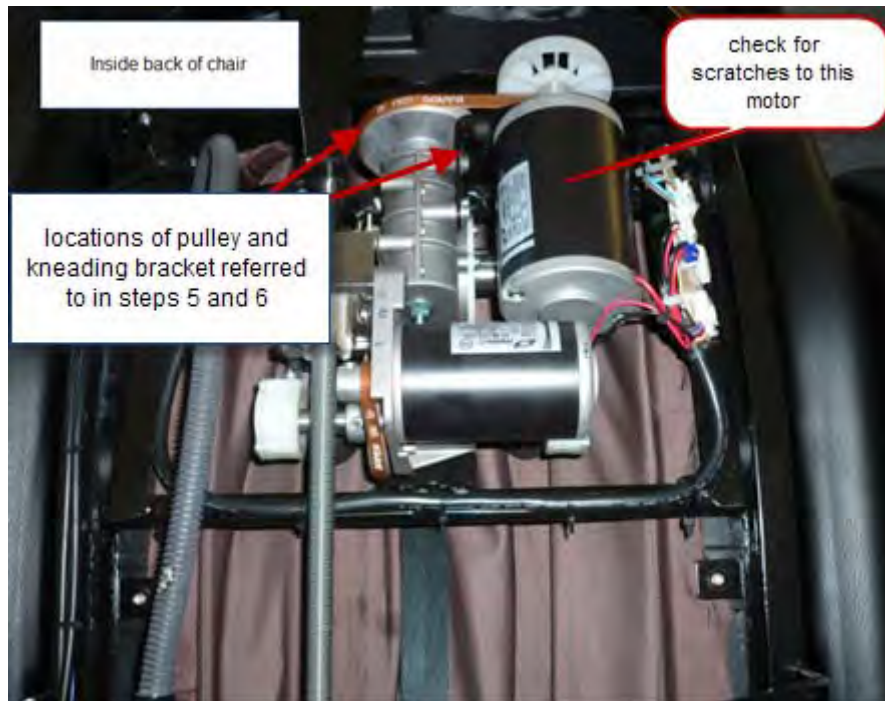
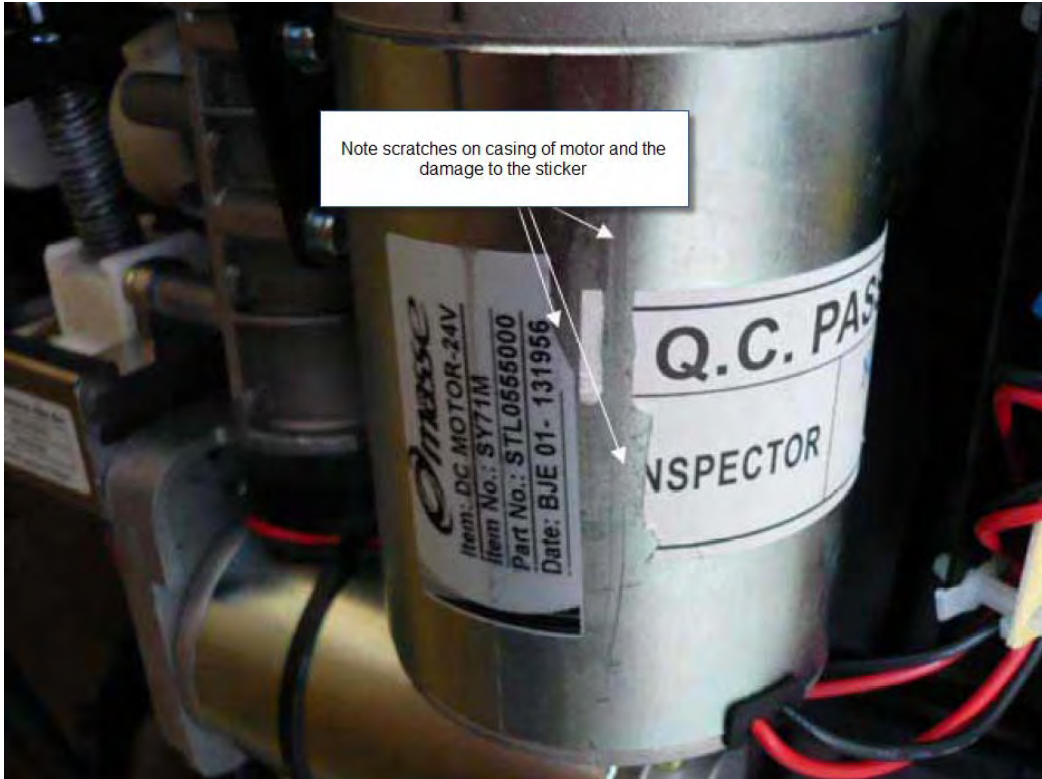
**Step 3:** Check the kneading motor for scratches to its casing or possible damage to the sticker if there is a sticker in the front side of the motor.

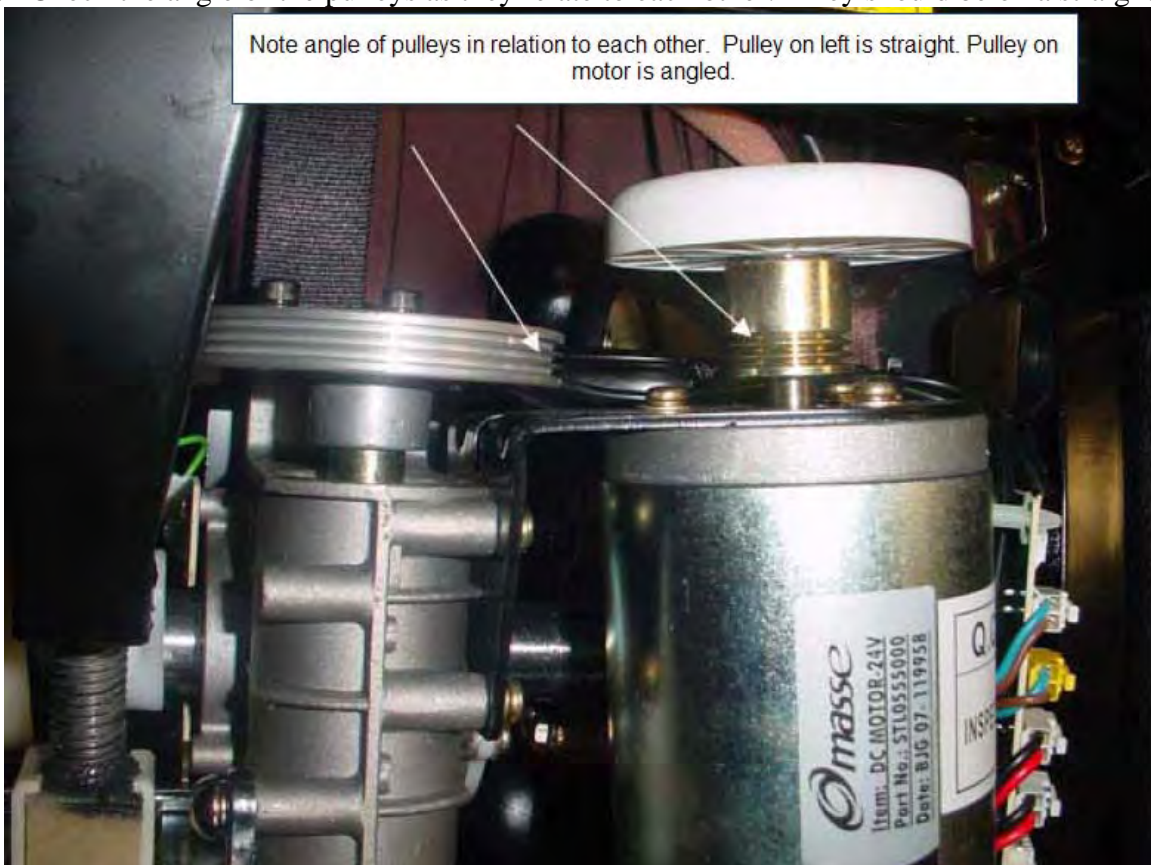
**Step 4:** Check the angle of the pulleys as they relate to each other. They should be on a straight line.

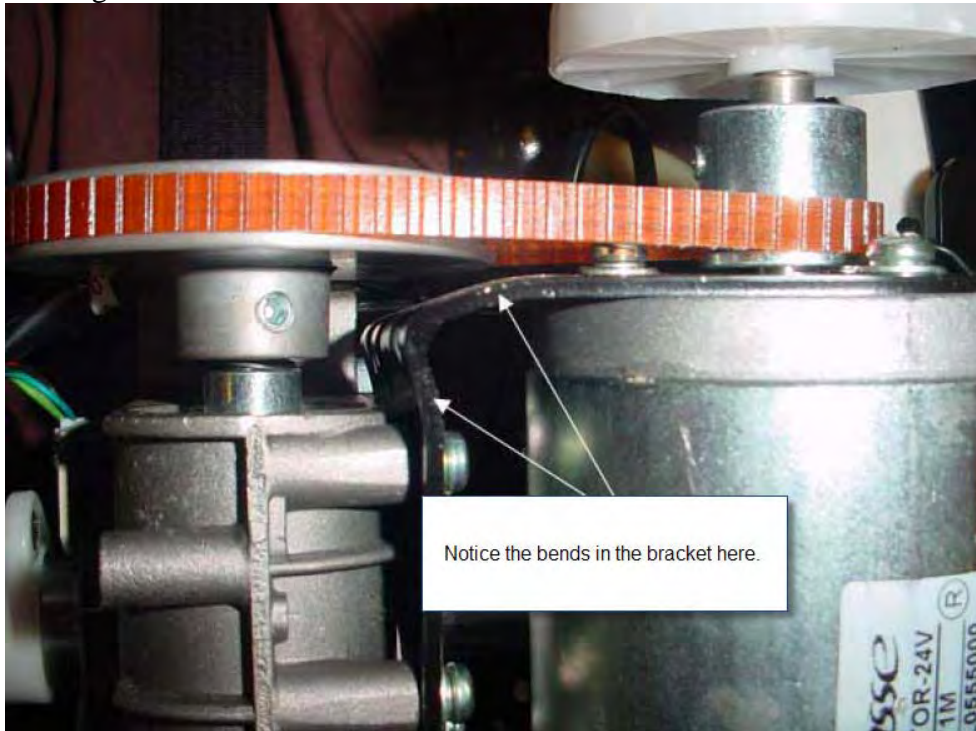
**Step 5:** Regardless of the condition of the stickers, the next thing to check is for the damage to the kneading motor fixing bracket.

Compare the above photo with a good bracket below.

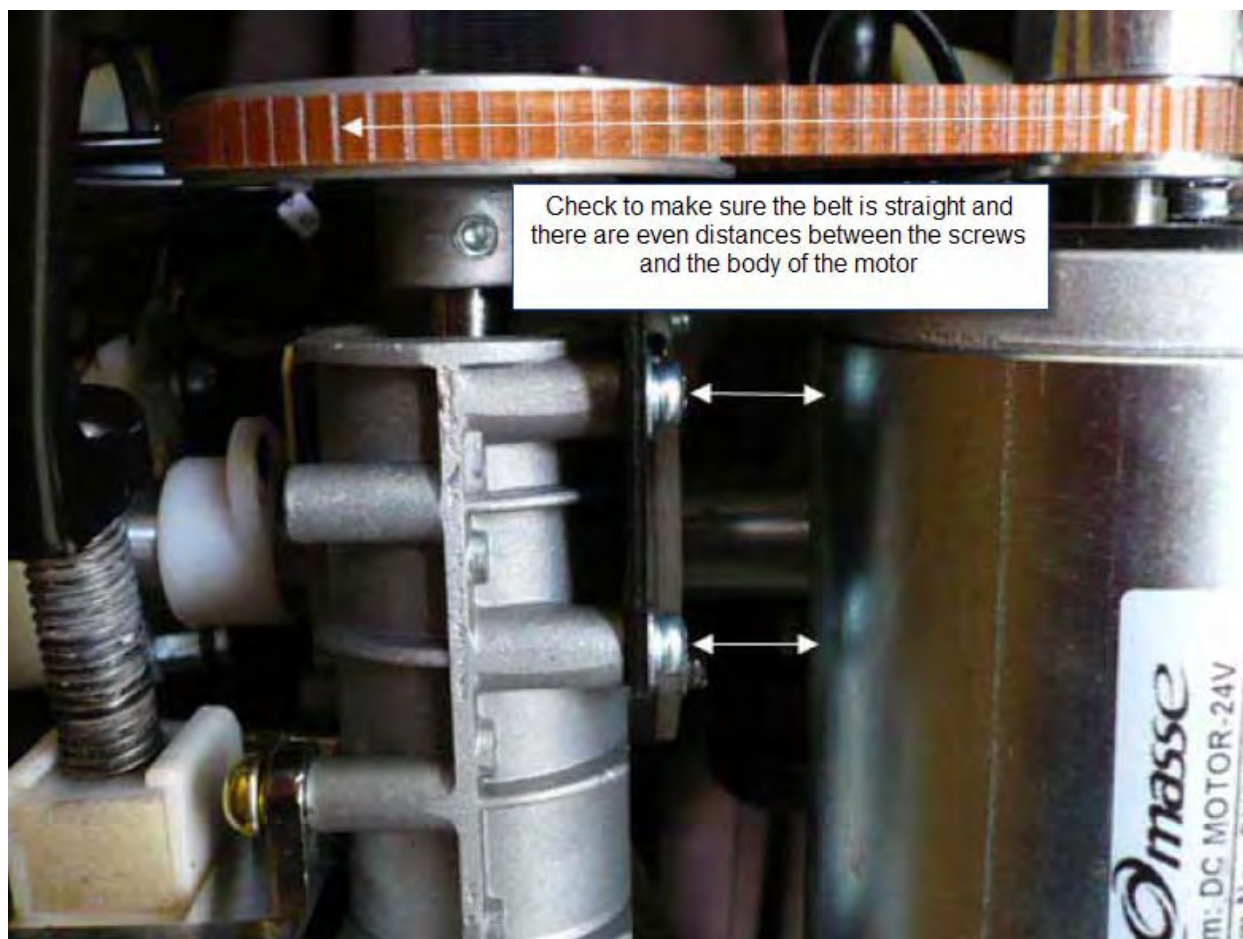
**Step 6:** Check the belt and make sure it is straight and that there is an even distance between the screws on the mounting bracket and the motor casing.

If the belt is not straight or the distances between the two screws and the motor above are not the same, you may have a damaged kneading bracket assembly.

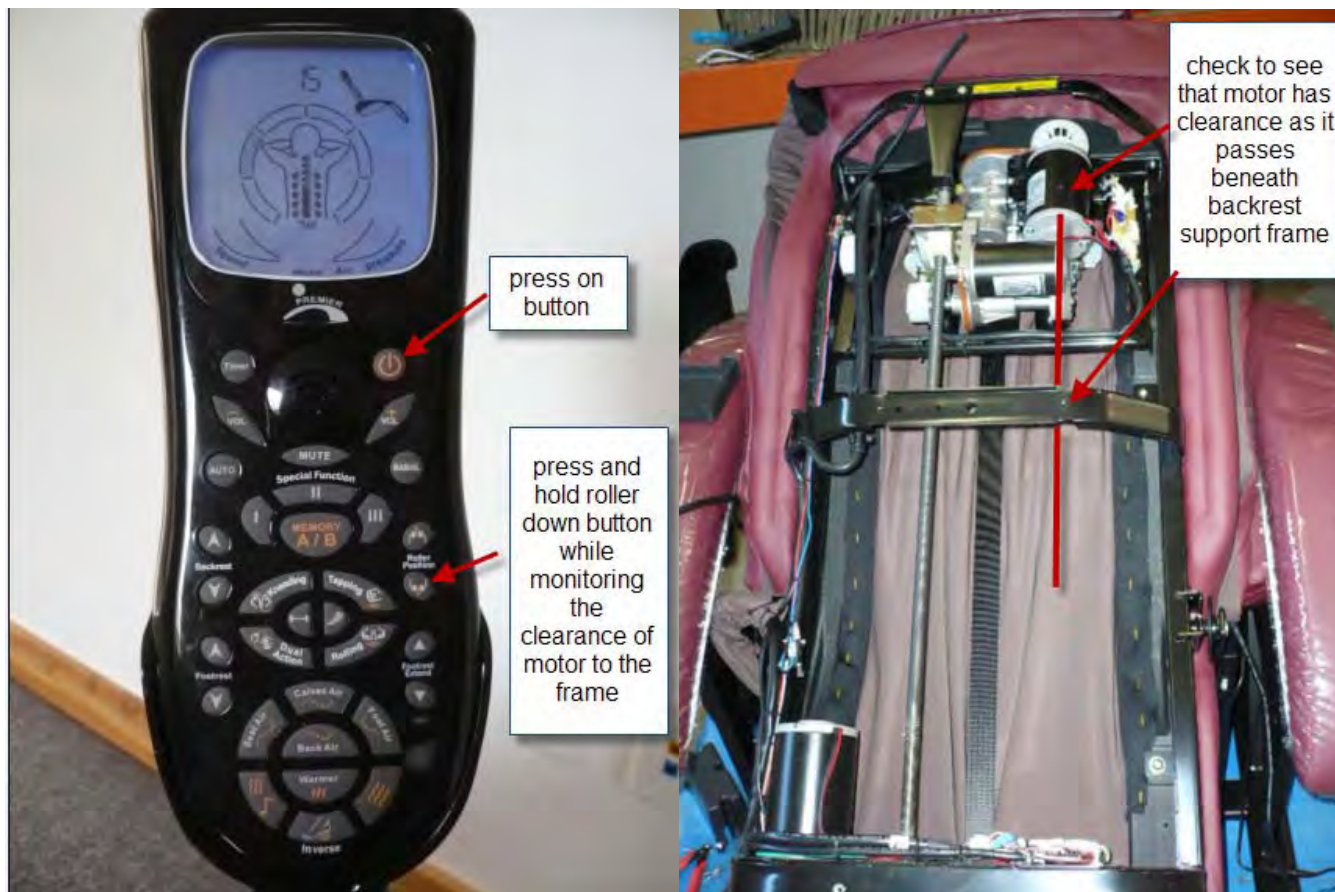
**Step 7:** Plug the chair back into the outlet and turn main switch on. Using the remote, turn chair on and then press and hold the “down roller position” button while monitoring the clearance of the kneading motor as it passes beneath the backrest frame bracket. Be sure to release the “down roller position” button if the motor is going to hit the backrest support frame.
